SUBJECT: First Five-Year Review Report  
Piper Aircraft Superfund Site  
Vero Beach, Indian River County, Florida

**First Five-Year Review Report for  
PIPER AIRCRAFT NPL SITE  
The New Piper Aircraft, Inc.  
Vero Beach, Indian River County, Florida**

**December 2003**

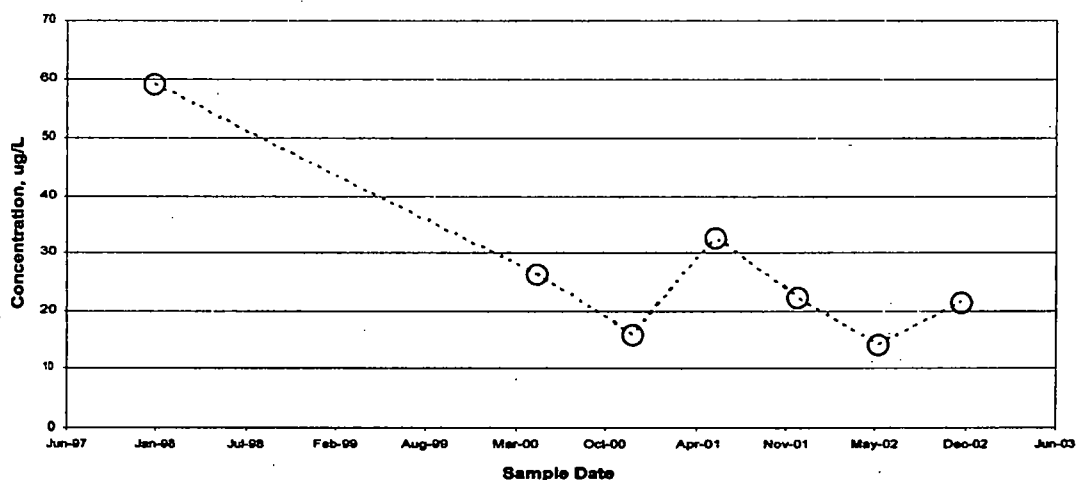
Figure 1. TCE Concentration Versus Time at MW-4S

eventually replaced with UVB-1A in 2001. The Five-Year Review Report indicates that while UVB-1A has a design capacity of approximately 50 gallons per minute, it has been operating at 15 gallons per minute. The Five-Year Review Report does not include any documentation of the estimated area of influence of UVB-1A or its predecessor, the UVB-1 well. Thus, while the concentrations of contaminants in samples from monitoring wells near UVB-1A show dramatic decreases following startup of that well, it is not clear the extent of the area of this apparently effective ground water remedial action. Based on data from some of the monitoring wells in this up-gradient part of the Site (MW-4S in particular; see Figure 1 below), there may not be much current effect of UVB-1A on part of the up-gradient contamination.

***Well UVB-1A has a design capacity of 200 plus GPM; the aerator which processes the influent from UVB-1A has a design capacity of 50GPM. The UVB-1 well took two years of operation before the shallow screened pumping zone became clogged with iron precipitate and the deeper receptor zone experienced the same process. It proved unsuccessful to concentrate redevelopment efforts on the shallow screened interval because the pump intake set at 44 feet below the screen provided conditions that were ideal for screen encrustation.***

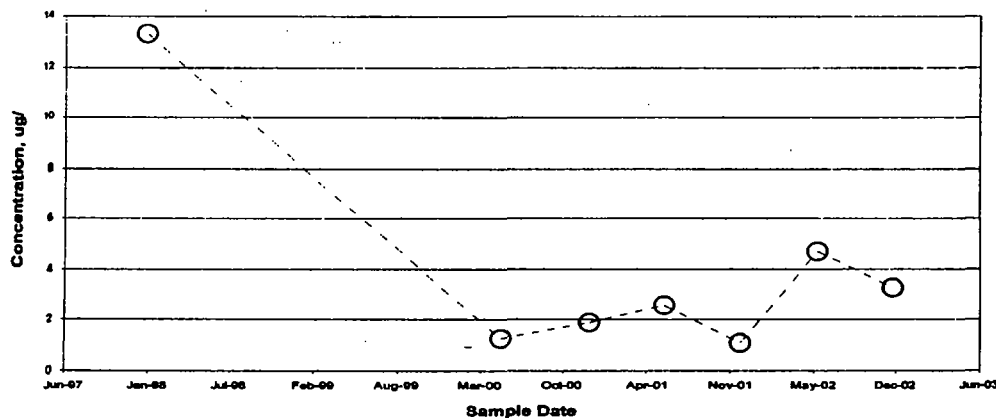
Figure 2. Vinyl Chloride Concentrations Versus Time at MW-17

- 3.2 Mid-plume monitoring wells appear to be poorly placed to track the progress of the remedial action. MW-16 is best located to monitor the progress of the remedial action, but data from that well are too variable over the period of UVB well operation to make any reasonable judgement about changes in water quality in the mid-plume area. MW-17 is another mid-plume well and data from that well suggest that the remedial action is having little or no effect on the concentration of vinyl chloride in that part of the plume (Figure 2).

*The MW-17 well area, some distance north of the interpreted axis of plume occurrence contains only low level VC in the intermediate depth range. The area will be included in modified remediation planning with regard to geoprobe tasking and possibly deeper*

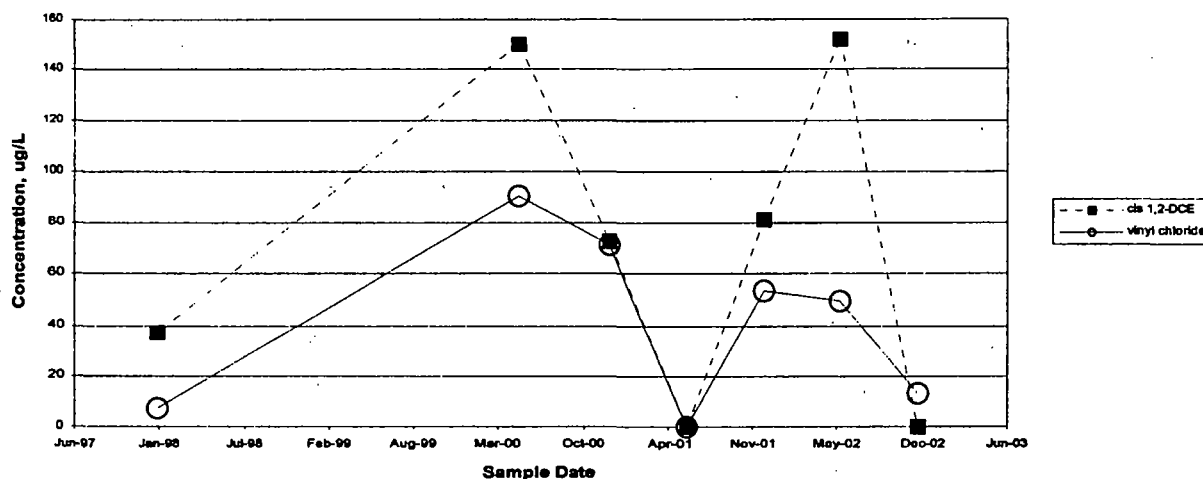
Figure 3. MW-16 Concentration Trends

At MW-16, time-concentration data present an unclear picture of time concentration trends for vinyl chloride and cis 1,2-DCE. These are the two contaminants of concern that have been detected at that location in concentrations periodically exceeding their respective MCLs. **Figure 3** shows the MW-16 time-concentration data for cis 1,2-DCE and vinyl chloride. The pattern of highly variable concentrations suggests either different well sampling and purging procedures or slightly different flow patterns in the aquifer. Either condition may result in a sample representing either deeper, more contaminated ground water or shallower, less contaminated ground water (or ground water that is at times more representative of the plume centerline concentrations in this part of the plume).

There is clearly a need for alternate monitoring locations or monitoring strategies in the mid-plume area. Neither MW-17 nor MW-16 appear to be properly placed to track the core of the contaminant plume in this area. MW-16 may be located in an area of steep concentration gradients, where minor changes in either flow direction or well purging and sampling procedures results in highly variable concentration changes between different sample events.

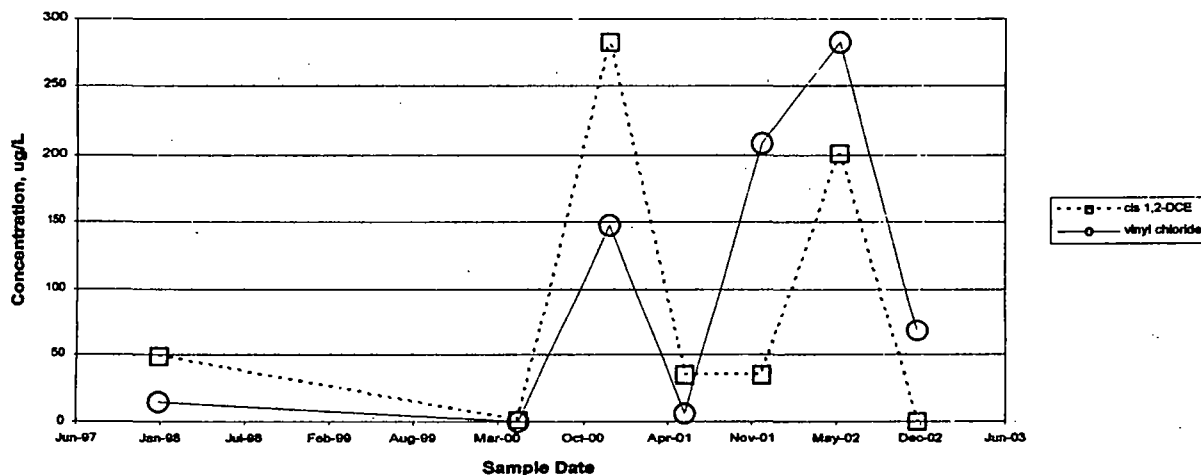
Figure 4. MW-19 Concentration Trends

**Figure 15 isopleths show a decrease in cis,-1,2 DCE from 1997 through 2002 in the area of MW-19. Isopleths are somewhat misleading in that they depict a smooth transition and connected occurrence of contamination. The residual contaminants probably occur in a three-dimensional random arrangement of small lenses and blobs, the placement of which is controlled by an interplay of hydrologic, geologic and phase relationship variables. Looking for a progressive downward trend in certain wells can be unproductive. The ups and downs in residual concentration shown by various wells despite a rigorous attempt to keep all sampling protocols identical are attributed to the sporadic and intermittent release of contaminants to the down gradient water flow occurring in a fairly anisotropic aquifer.**

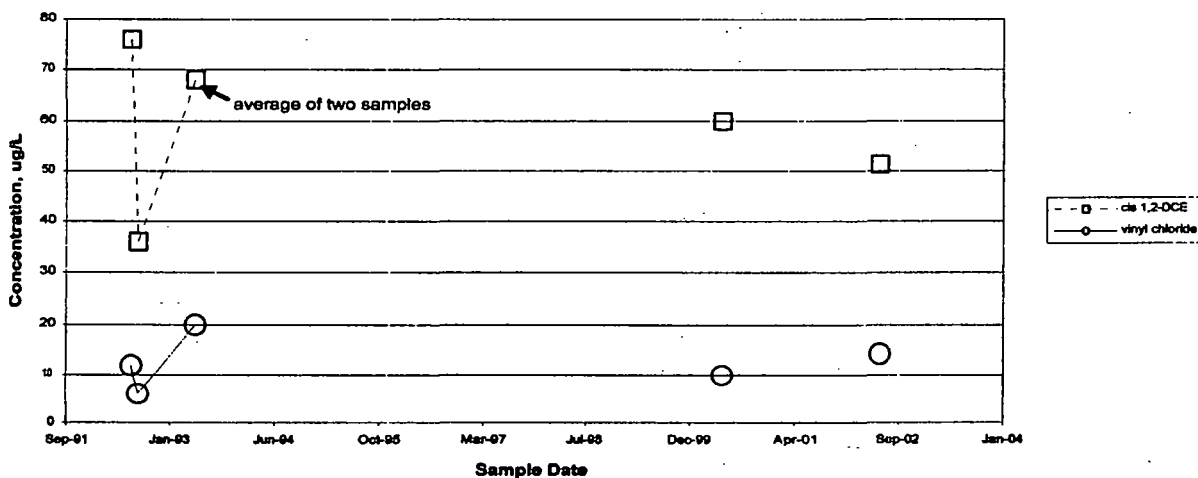
Figure 5. Vero Beach Well #15 Concentration Trends

- 4.7 **City of Vero Beach Well (CW-15)** - Ground water quality data from the city well #15 are presented in Table 3 of the Five-Year Review Report. Only two samples from the well are included in the table (May 2000 and June 2002). The May 2000 sample contained 59.7 ug/L cis 1,2-DCE and 9.8 ug/L vinyl chloride. The June 2002 sample contained 51.2 ug/L cis 1,2-DCE and 14.3 ug/L vinyl chloride. This limited amount of data does

not indicate that the ground water remedial action at the Piper Site is effectively reducing concentrations at the water-supply well. For further comparison, data from city well #15 that were obtained during the RI are also summarized in EPA's 1993 Record of Decision. These data indicated that in the 1992 to 1993 time period, cis 1,2-DCE was present at concentrations of between 36 and 76 ug/L, while vinyl chloride was present at concentrations in the range of 5.9 to 20 ug/L. **Figure 5** shows time-concentration data from Vero Beach well #15.

The presence of continuing concentrations of vinyl chloride above its stated MCL and at concentrations comparable to those observed almost a decade earlier is an indication that the remedial action needs to be modified to better control movement of contaminated ground water beyond the more downgradient area of ground water remediation at the Site (the UVB-2 area). This comment was also made by FDEP.

*Agreed; NewPiper has been investigating alternative remedial technology to augment existing remedial methodology.*

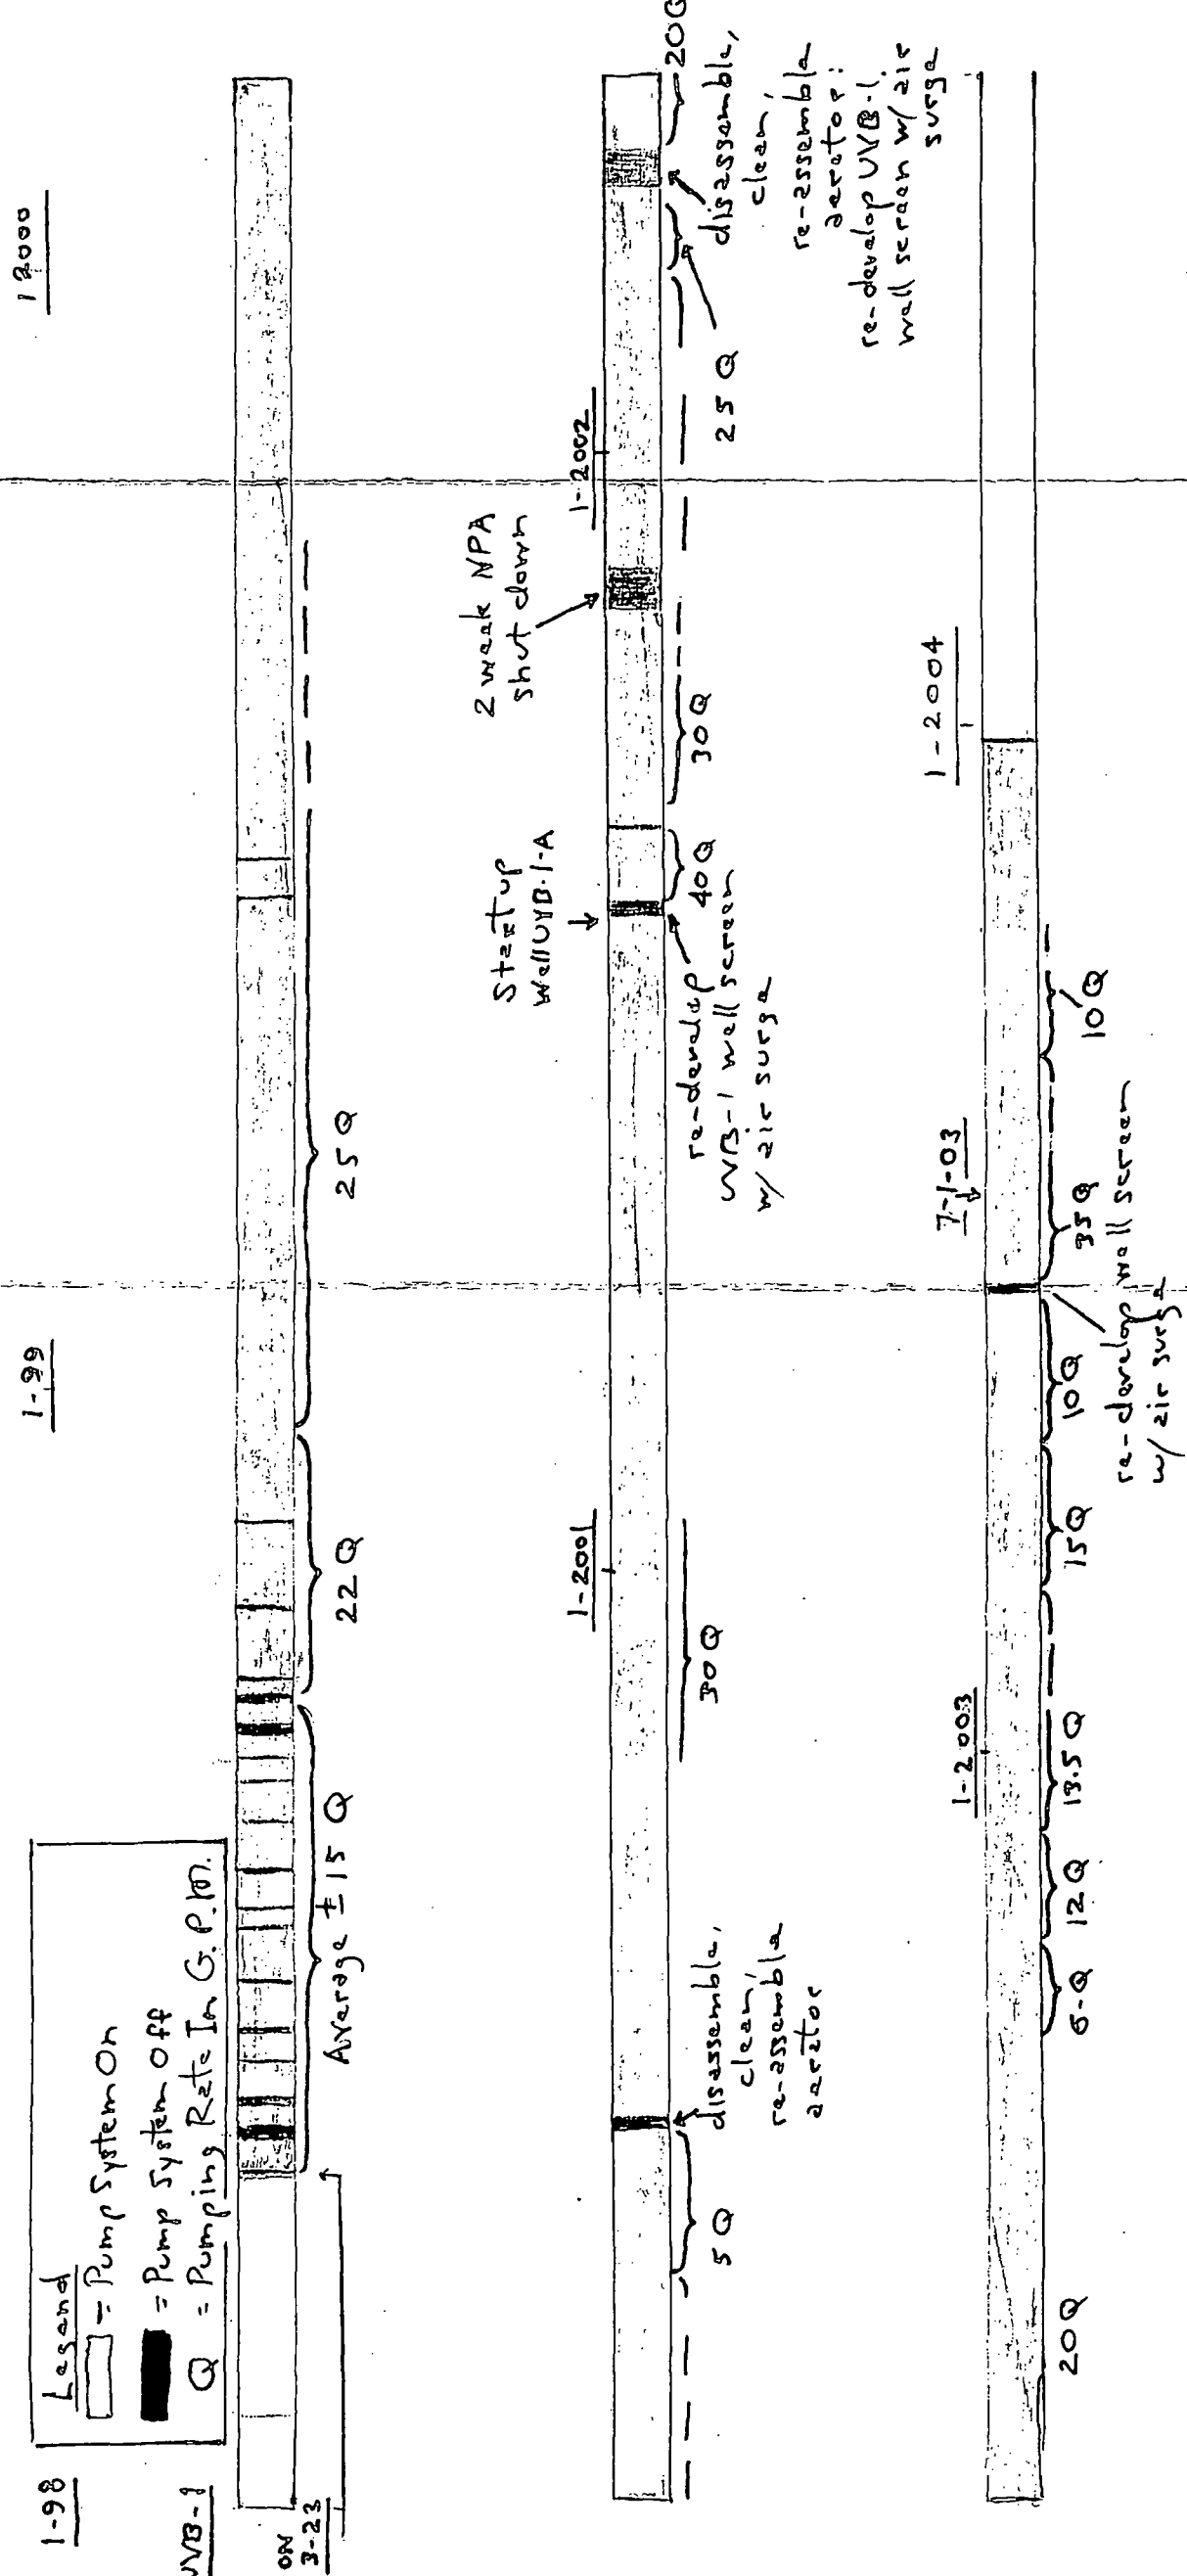
FIGURE 18

Figures 18 & 19 present an operational history of the two UVB wells highlighting significant reasons for system shutdowns including dates of periods to remove red mud from screen sections. The conditions leading to each well development and aerator cleaning were characterized by gradual loss of effluent flow which the receptor wells could accept without overflowing at land surface.

Re-development during the construction testing period in May 1998, did not increase the specific capacity of well *UVB-1* significantly. Numerous electrical problems plagued the *UVB-1* system during the first year of operation because of unnecessary electrical circuit and design complexities. Frequent troubleshooting and simplifying the electrical cabinet has increased the reliability of equipment and maintained more consistent running conditions.

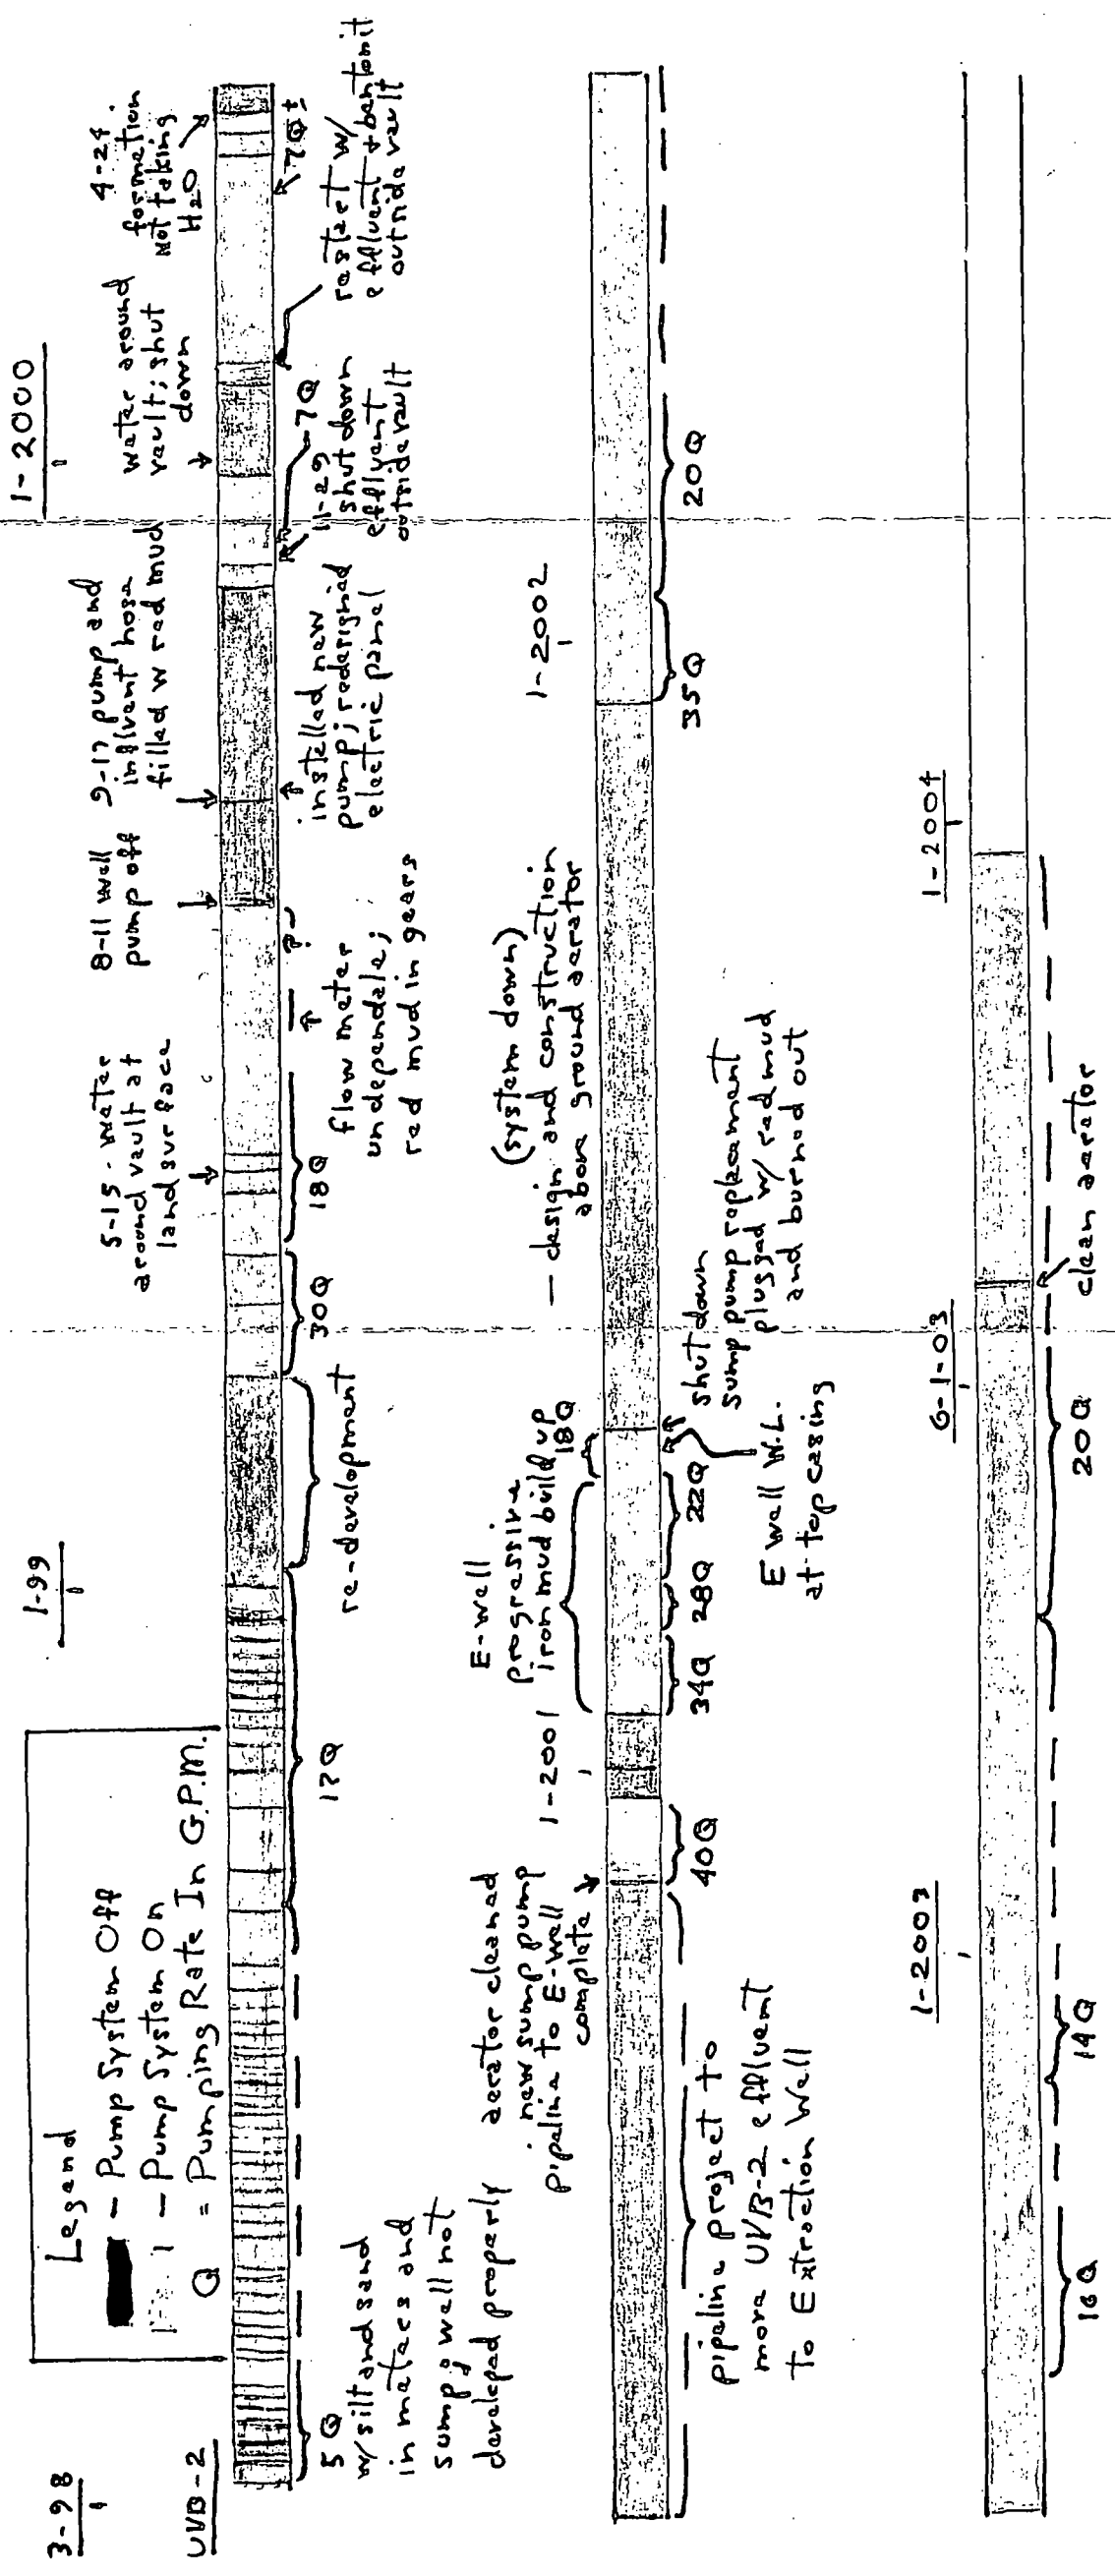
FIGURE 19

19. November 2001 - UVB-2 sub-surface vault Aeration System was replaced with an above-ground Aeration System, similar to UVB-1 because of continued problems with equipment malfunctions and flow rate. Additionally, an underground treated effluent discharge line was routed to the "Old Piper Extraction Well" to increase system pumping rate.

In well system UVB-2, the above problems became compounded by failure of the casing well seal (Bentonite), and resultant upward stoping of effluent causing earth sapping under the well vault causing vault subsidence and effluent turbid with bentonite flowing at land surface. It is interpreted that a faulty gravel pack job left the upper part of the upper screen section (see Figure 12), exposed to bentonite seal material. When aquifer materials became resistant to the flow of effluent, the effluent took the path of least resistance runneling up around the ten-inch casing and escaping around the vault floor to land surface.
